Learn from the mistakes of others; you'll not live long enough to make them all yourself . . . **Issue 2/2005**

## Low Visibility Approach Leads to CFIT

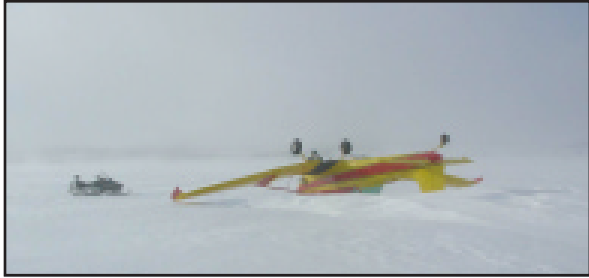
### TSB Final Report A03A0013—Fuel Starvation / Forced Landing

On February 4, 2003, a single-engine Cessna 188B aircraft was being ferried from Canada to Africa and was en route from St John's, N.L., to Goose Bay, N.L. On the first leg of the trip, approximately 1 hr 30 min into the flight, the pilot attempted to transfer fuel from a modified fuel tank to the wing tanks. The engine stopped producing power, and the pilot then carried out a forced landing in a snow-covered frozen bog. The aircraft nosed over during the landing roll and came to rest in a nose-down attitude. The pilot was not injured.

1. Water contamination in the fuel system led to internal corrosion and solid particle contamination of the fuel screens. The contamination and water/ice led to a complete blockage of fuel flow to the engine, and the engine stopped.
2. The operator dismissed the fuel transfer problem on the initial ferry flight attempt as being caused by improper operation of the fuel system. The operator did not ask the maintenance company, which was contracted only to carry out specific tasks, to do a thorough inspection of the ferry tank fuel system.
3. An adequate examination of the fuel system after the initial ferry flight attempt would probably have revealed discrepancies (such as an improperly operating fuel system or fuel contamination) that would have been corrected before the second ferry flight attempt.

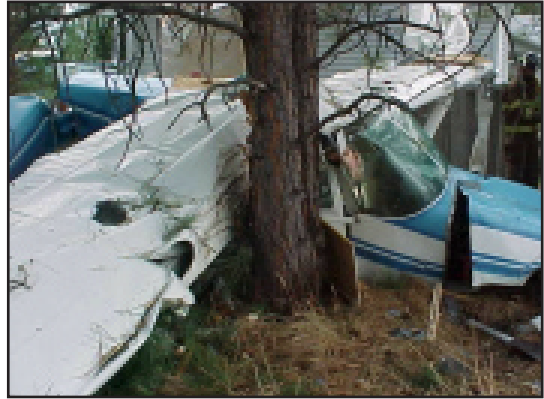
### TSB Final Report A03P0239—Collision with Terrain

On August 10, 2003, a Cessna 210A aircraft with a pilot and one passenger aboard was on a visual flight rules (VFR) flight from Prince George, B.C., to Princeton, B.C. On reaching Princeton, the pilot joined a left-hand downwind pattern for Runway 03 and intercepted the final approach path at approximately 5 NM from the aerodrome. Approximately 3 NM from the aerodrome, the aircraft was slightly high and the pilot selected idle power and extended the landing gear. When the throttle was selected to idle, the pilot smelled fuel fumes. On final approach for Runway 03, the pilot advanced the throttle to correct the descent, but the engine (Teledyne Continental Motors IO 470-E) did not respond, even at full throttle.

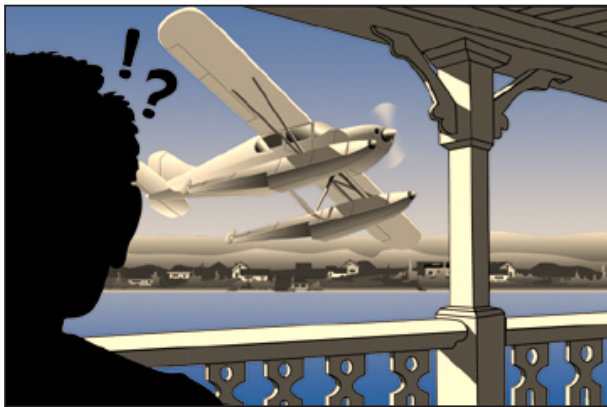
Artist's impression of the event.

I calculated that a turn radius for 60 mph and 20 degrees of bank requires about 750 ft. A 135-degree turn (southwest to east) would need 1 300 ft. If the aircraft started 100 ft from the north bank of the river, and flew the turn for 25 s with a 5 kt drift to the southeast, we see that the remaining clearance is about 300 ft, since the boathouse is built on foundations 100 ft out into the river. For 65 mph, a more realistic speed for best climb, the turn needs 1 500 ft and the clearance at the boathouse shrinks to 100 ft; close to my estimate of 50 yd for the closest approach.
